Infrared Testing Resolves Post-Construction Disputes

From High-Profile Monthly: Facilities Development News, November 2007

By Peter Brooks, Infra-red Analyzers

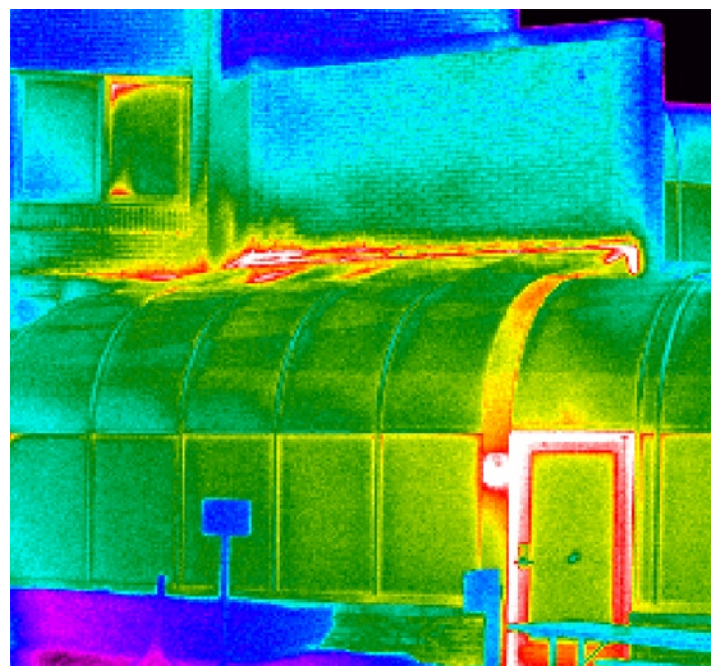
Excessive air leakage can overwhelm properly sized and installed HVAC systems.

Several years ago, erratic humidity levels in a newly constructed museum forced facility engineers to delay moving art pieces into the new building. Our infrared testing revealed that large quantities of air were leaking into and

out of the building, which prevented the air handling system from maintaining the desired humidity level. Armed with our detailed information about the locations of the air leakage, the contractor was able to repair the problem areas. The building's HVAC system was then able to control the air exchange rate and maintain proper humidity.

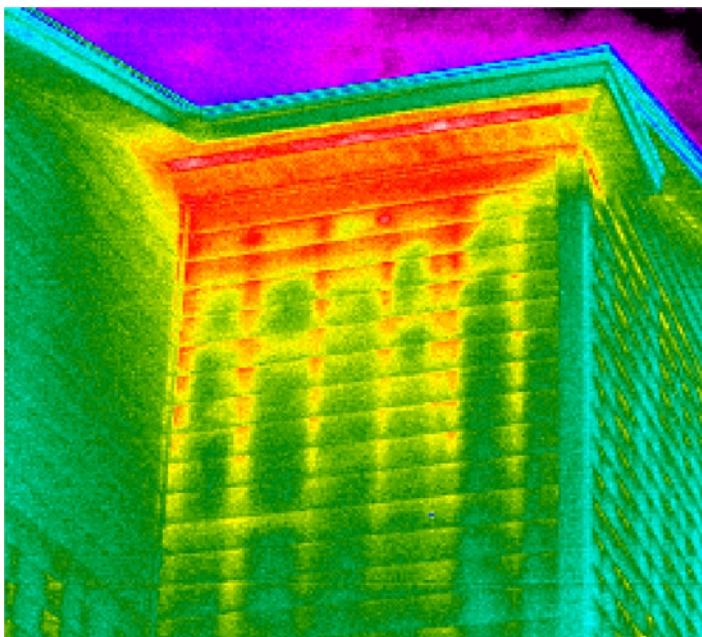
Newly constructed buildings can have significant heat loss problems.

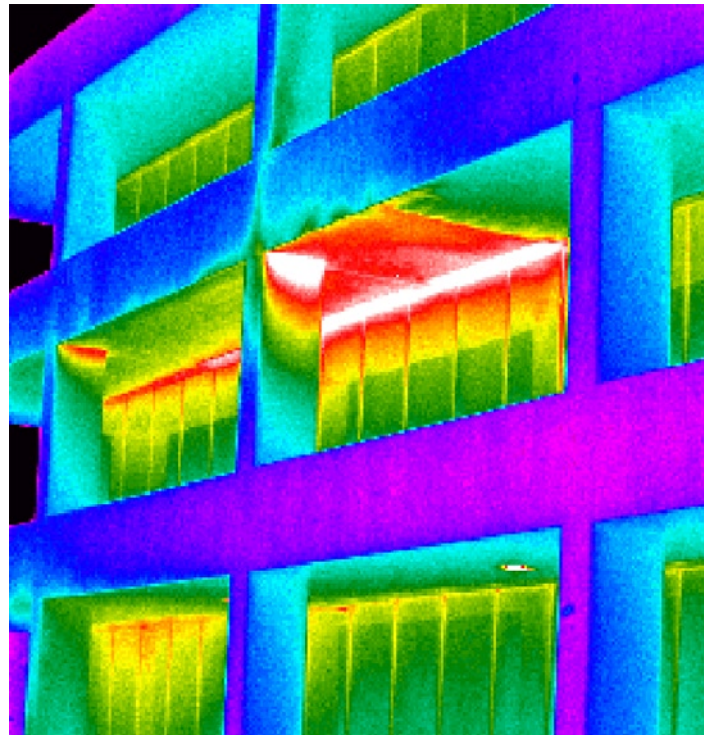
Isolated heat losses can create serious problems even though most of the building is performing well.
