From High-Profile Monthly: Facilities Development News, October 2007

By Peter Brooks, Infra-red Analyzers

Infrared and the Building Envelope

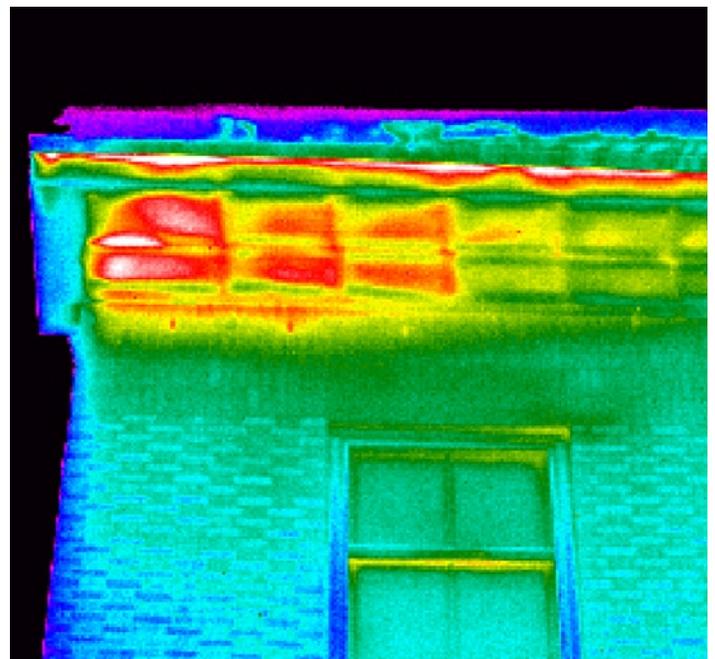
Ice dams are often caused by excessive heat losses near the eaves.

Infrared thermography is also an excellent tool for detecting the underlying causes of ice dams. Ice dams occur when excessive heat loss through the roof system melts snow accumulated on the roof. When the melt water reaches a colder area of the roof, it freezes and forms a "dam". Ice dams can cause extensive damage to roofing and wall systems, creating yet more opportunities for water to enter the building.

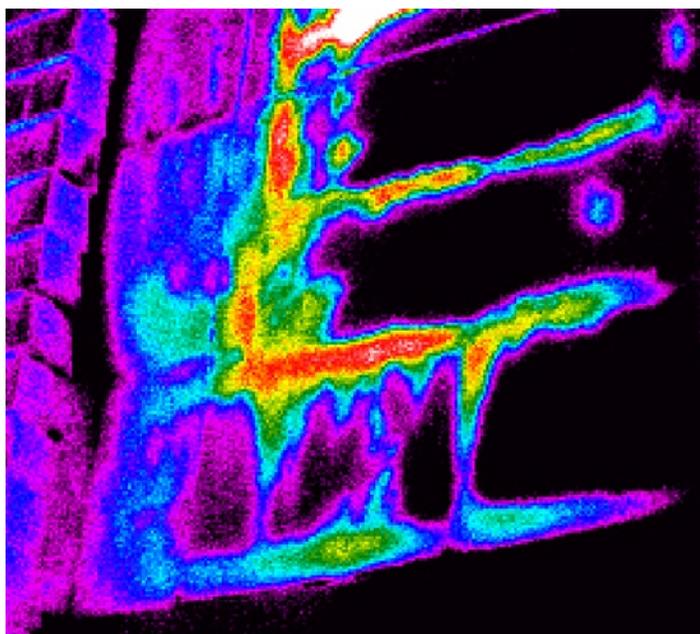
Thermography is an ideal tool for isolating water-damaged areas in EIFS systems.

chitectural details and construction techniques. Newer construction technologies can present additional challenges in the ongoing struggle to keep water in its place. Exterior insulation and finish systems (EIFS) may absorb water through joints and through breaches in the finish. Thermography is ideally suited to locate faults in these and other exterior finish systems.
