From High-Profile Monthly: Facilities Development News, September 2007

By Peter Brooks, Infra-red Analyzers

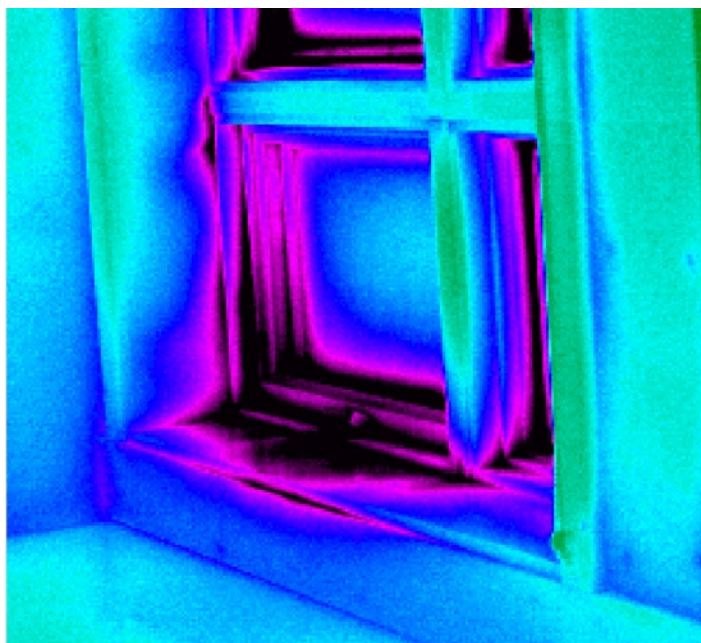
Even newly installed windows can have serious performance issues.

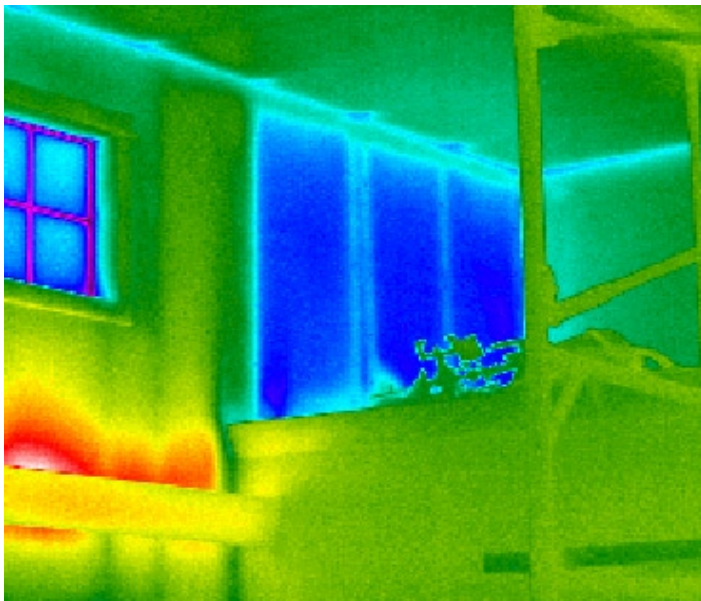
Infrared testing reveals source of cold spot: missing insulation.

Newly constructed or renovated buildings can have hidden design and construction flaws that create serious problems down the road. Our certified thermographers recently performed a quality control inspection of new construction on a college campus. Over fifty significant problem areas were identified, including poorly installed insulation, cold air infiltration through inadequate air and vapor barriers, and cold air leakage through poorly performing windows.
