From High-Profile Monthly: Facilities Development News, September 2007

By Peter Brooks, Infra-red Analyzers

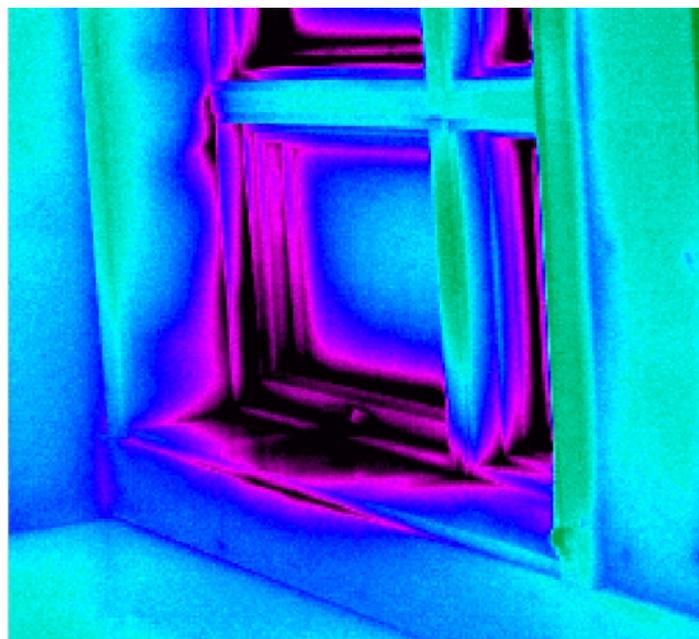
Even newly installed windows can have serious performance issues.

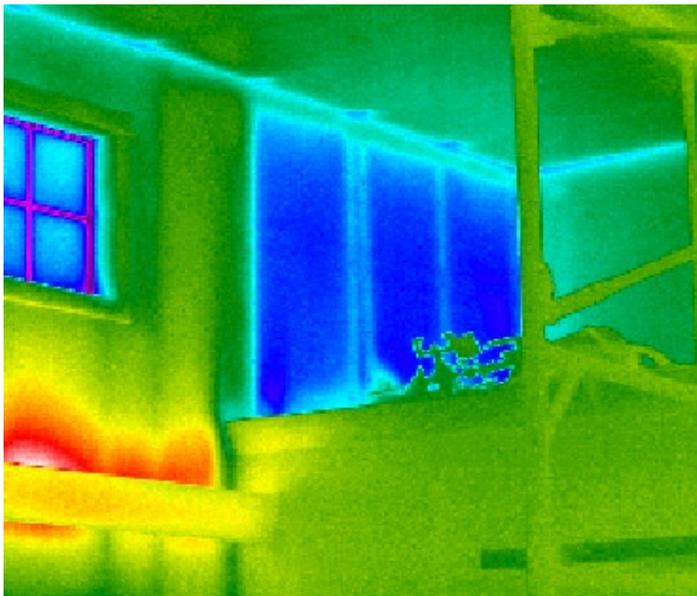
Infrared testing reveals source of cold spot: missing insulation.
