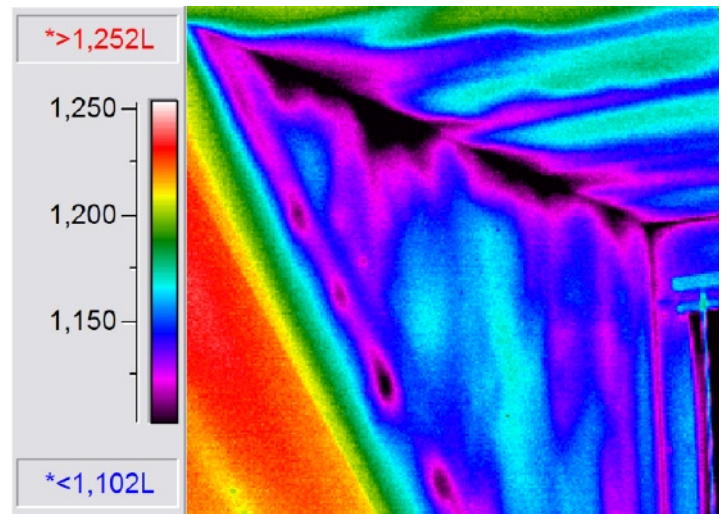
Thermogram #3 - Substantial conduction losses were creating very cold temperatures on the interior of this newly renovated dormer.

In some situations, conduction losses can also have a profound effect on occupant comfort. A 150-year-old college building in which the attic had been converted into offices for professors and staff was similarly scanned with an infrared camera. After renovation, the entire floor of the building was experiencing very chilly interior temperatures, frozen pipes, and water damage. Thermogram #3 depicts an office dormer wall and ceiling. In the lower left hand corner of the thermogram can be seen a section of the pitched roof where the insulation is performing well. The wall and ceiling of the dormer are extremely cold due to poorly installed insulation and an inadequate exterior air barrier. The institution used the findings of the thermographic testing to guide an intensive effort to correct the detected problems.

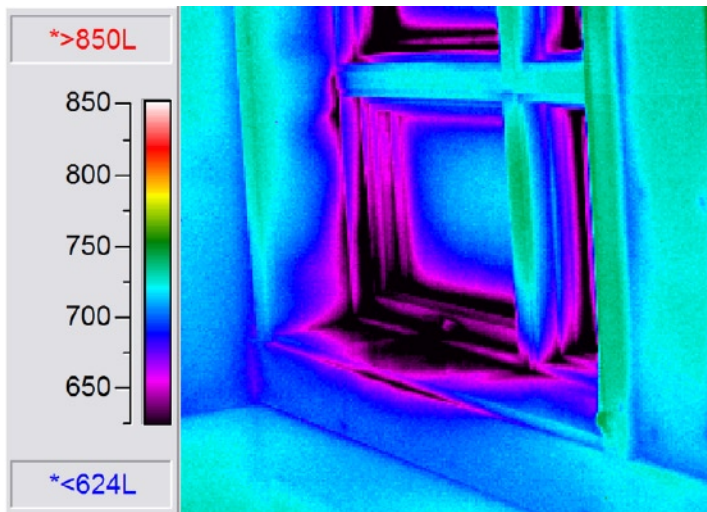
Thermogram #6 - Even newly installed windows can have serious performance issues.

Many newly constructed or renovated buildings have hidden design and construction deficiencies that can create serious problems in the future. Certified thermographers were recently asked to perform a quality control inspection of new construction on a college campus. Thermogram #5 depicts an interior view of a wall/cathedral ceiling joint illustrating substantial amounts of cold air infiltrating through an inadequate air and vapor barrier. Thermogram #6 reveals significant cold air leakage typical of the performance of the newly installed awning windows. Substantial
